TURBO FAILURE: OIL STARVATION

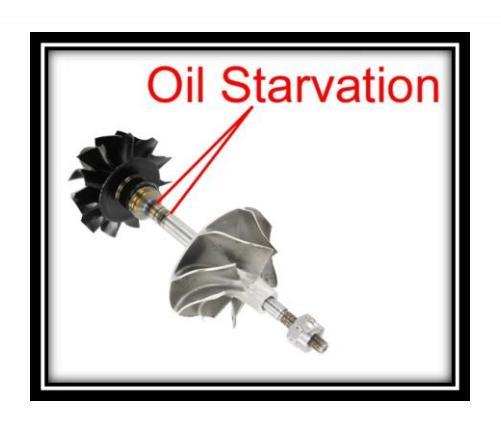
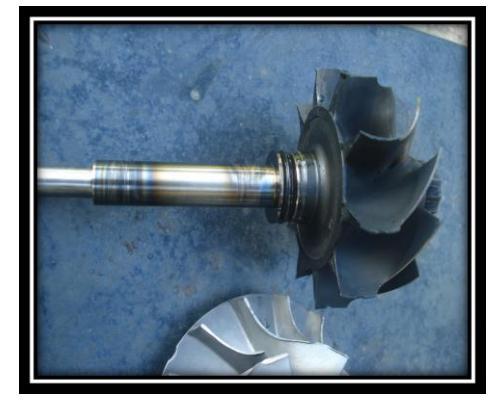
- Incorrect oil inlet gasket restricting oil supply.
- A blocked, damaged or poor quality oil filter.
- Worn oil pump.
- Failure to prime the replacement turbo with oil during fitting.
- The engine not being used for long periods, particularly in cold weather.
- Low engine oil level in the sump.
- A bent or kinked oil feed pipe.
- Carbon deposits (coking) in the oil feed pipe.
- Blockage caused by applying silicone to the oil inlet gasket.

- Do not use silicone on oil gaskets; it can easily become detached and block oil passages.
- Clean or replace oil inlet pipes to eliminate any carbon deposits or sludge that could restrict oil flow to the bearings.
- It is important to check the oil pressure and oil supply to the turbo.
- Always use fresh oil and new oil filters as recommended by the engine manufacturer when fitting a new turbo.
